KENWOOD Service Bulletin

ASB-1009

Subject: TS-950SDX 3rd Order IMD Standardization Date: January 25, 1993

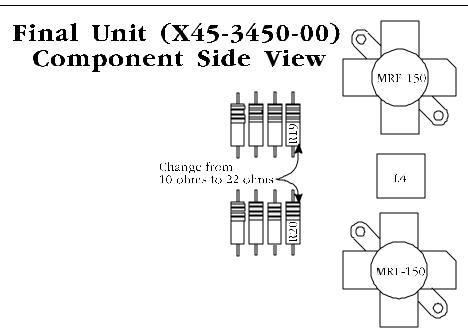
3rd Order IMD figures have been noted that do not meet our standard value of -32 to -35 dB.

We have found that this symptom can be caused by either improper bias to the final transistors and/or because of distortion introduced by the 73.05 MHz IF mixer circuit.

- 1. On the Final Unit (X45-3450-00) change R19 and R20 from 10 ohms to 22 ohms. (Fig. 1)
- 2. On the IF Unit (X48-3100-00): (Fig. 2)
 - a. Change R195 from 56 ohms to 150 ohms
 - b. Change R197 from 220 ohms to 150 ohms
 - c. Change R198 from 220 ohms to 150 ohms
 - d. Change R204 from 10K ohms to 4.7K ohms
