KENWOOD Service Bulletin

ASB-1026

Subject: TS-950SDX "Click Noise" with NOTCH ON **Date:** June 7, 1993

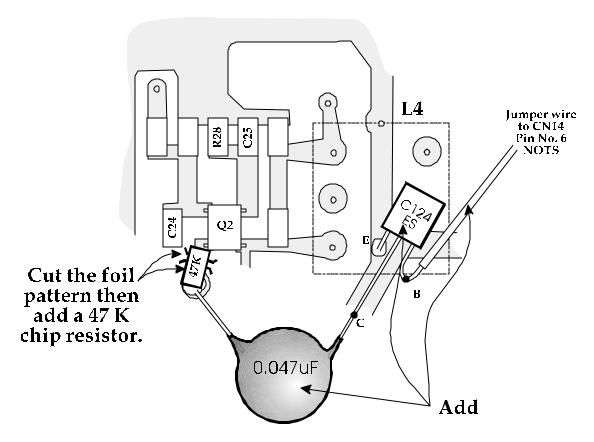
Signal Unit (X57-4130-00) Foil Side View

A click noise might be generated when receiving a strong signal (S-9 or above) when the NOTCH is ON and the Notch Control is turned away from the notch point.

Lengthening the AGC release time of the IF Amp just before the NOTCH circuit will correct this symptom. The enclosed modification has been designed to change the time constant only when the NOTCH circuit is activated. Do not install this modification on sets that do not exhibit this symptom as the AGC FAST time constant is affected by this change.

- 1. Cut the printed circuit foil pattern between the test point (TP) and gate 2 of Q2 as shown.
- 2. Install the 47 K ohm chip resistor from TP to gate 2 of Q2.
- 3. Add a 0.047 uF ceramic capacitor as shown in the accompanying illustration.
- 4. Add the DTC124ES transistor as shown.

Note: The .047 uF capacitor and the digital transistor must be connected together as shown and installed so that they do not touch the surrounding circuit board patterns.

5. Install a jumper wire from the base of the digital transistor to pin number 6 of CN14.
