ASB-1027

Service Bulletin

Subject: TM-732A Protection of Q201 in 430 MHz Unit Date: June 28,

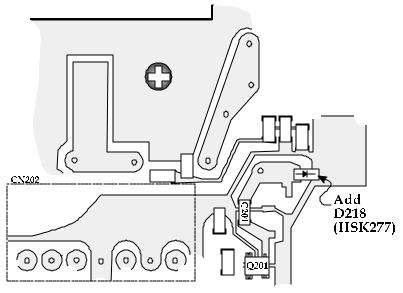
X57-4000-11 Foil Side View

Q201 the first RF Amplifier in the 430 MHz unit fails at random.

Addition of diode D218 in parallel with diode D214 in the RA line provides increased surge protection for Q201.
