Service Bulletin

ASB-1028

Subject: TH-28/48/78 Difficult Battery Insertion
1993

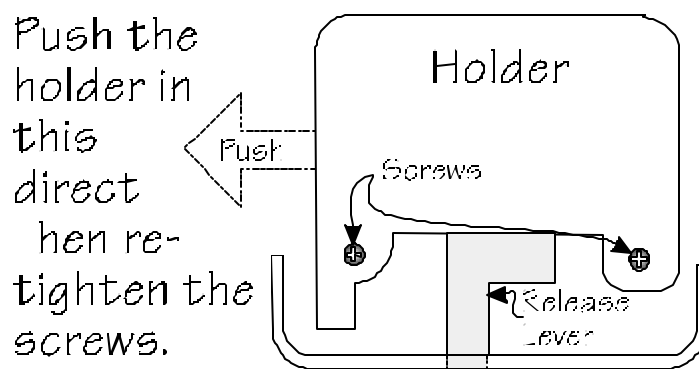
Insertion of the battery into the transceiver is difficult or impossible due to problems with the release lever.

1. A temporary cure is provided by loosening the two screws securing the holder, shifting the holder to the extreme left, then retightening the screws.
2. A permanent fix is provided by replacing the holder and release lever with new parts that have been deburred and modified to allow relocation of the release lever.
