ASB-1052

Service Bulletin

Subject: TS-950SD 18.115 MHz Spur Date: March 28, 1994

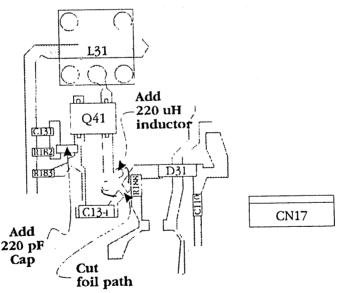
IF Unit (X48-3060-00) Foil Side View

Transmitting on 18.1145 MHz causes a spur to appear at 18.1150 MHz with the antenna tuner on.

Add the low pass filter shown in the accompanying diagram to the input circuit of mixer Q41 on the IF Unit (X48-3060-00). This filter will increase the attenuation by approximately 20 dB.
