# KENWOOD Service Bulletin

ASB-1061

**Subject:** TM-733A PL Tone Bleed Through **Date:** December 5, 2006

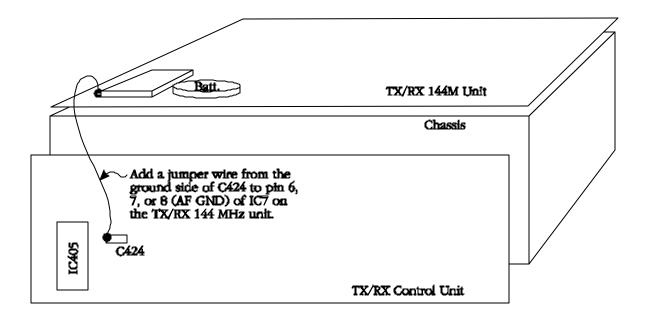
When transmitting a PL tone a "humming noise" might be heard coming from the internal speaker of the TM-733A. This is caused by a difference of potential between the tone generating circuit and the AF amplifier circuit.

- 7. Install the new screws and star washers.
- 8. Solder a jumper wire from the ground side of C424 and pin number 8 of IC7 as shown in the accompanying illustration.
- 9. Reverse steps 1 5 for reassembly.
