Elecraft K2 Keying Modification Instructions

Rev. A, Feb. 3, 2004

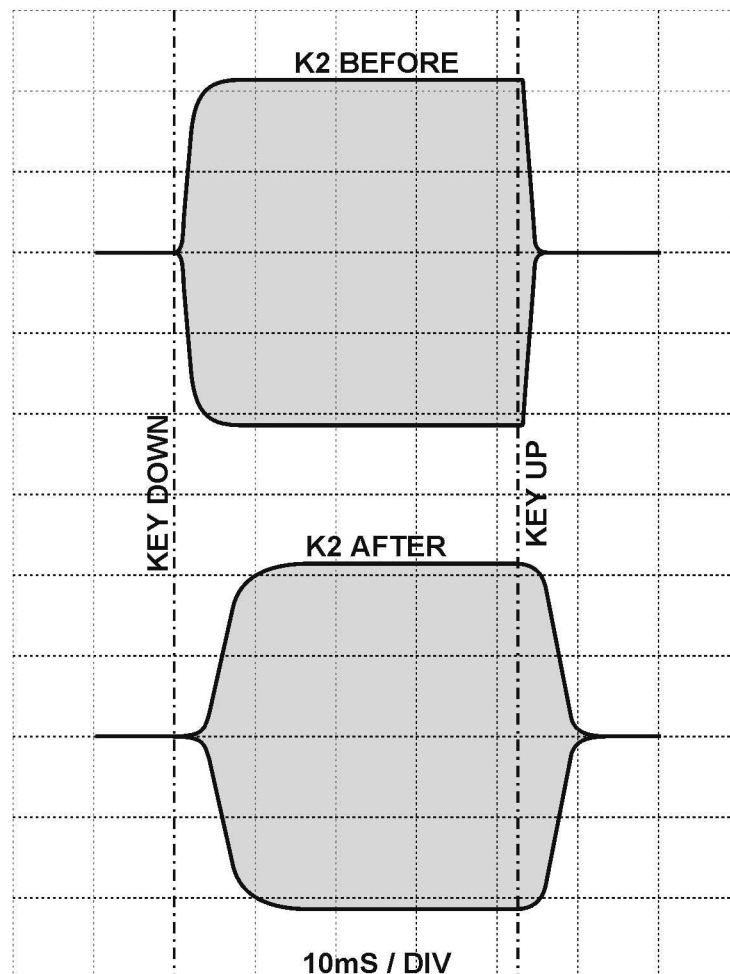
Recent analysis has shown that the keying bandwidth of many transceivers is excessive. A consensus has emerged that a sigmoidal (S-shaped) envelope, rather than a classic R-C exponential envelope, is ideal. The K2 can be modified accordingly. As shown below, the new keying waveform has longer rise and fall times, and the abrupt falling edge is eliminated.
