## Trio / Kenwood TS-430S information.

#### **Intermittent Drop in Power Output, Erratic ALC behaviour, SSB distortion:**

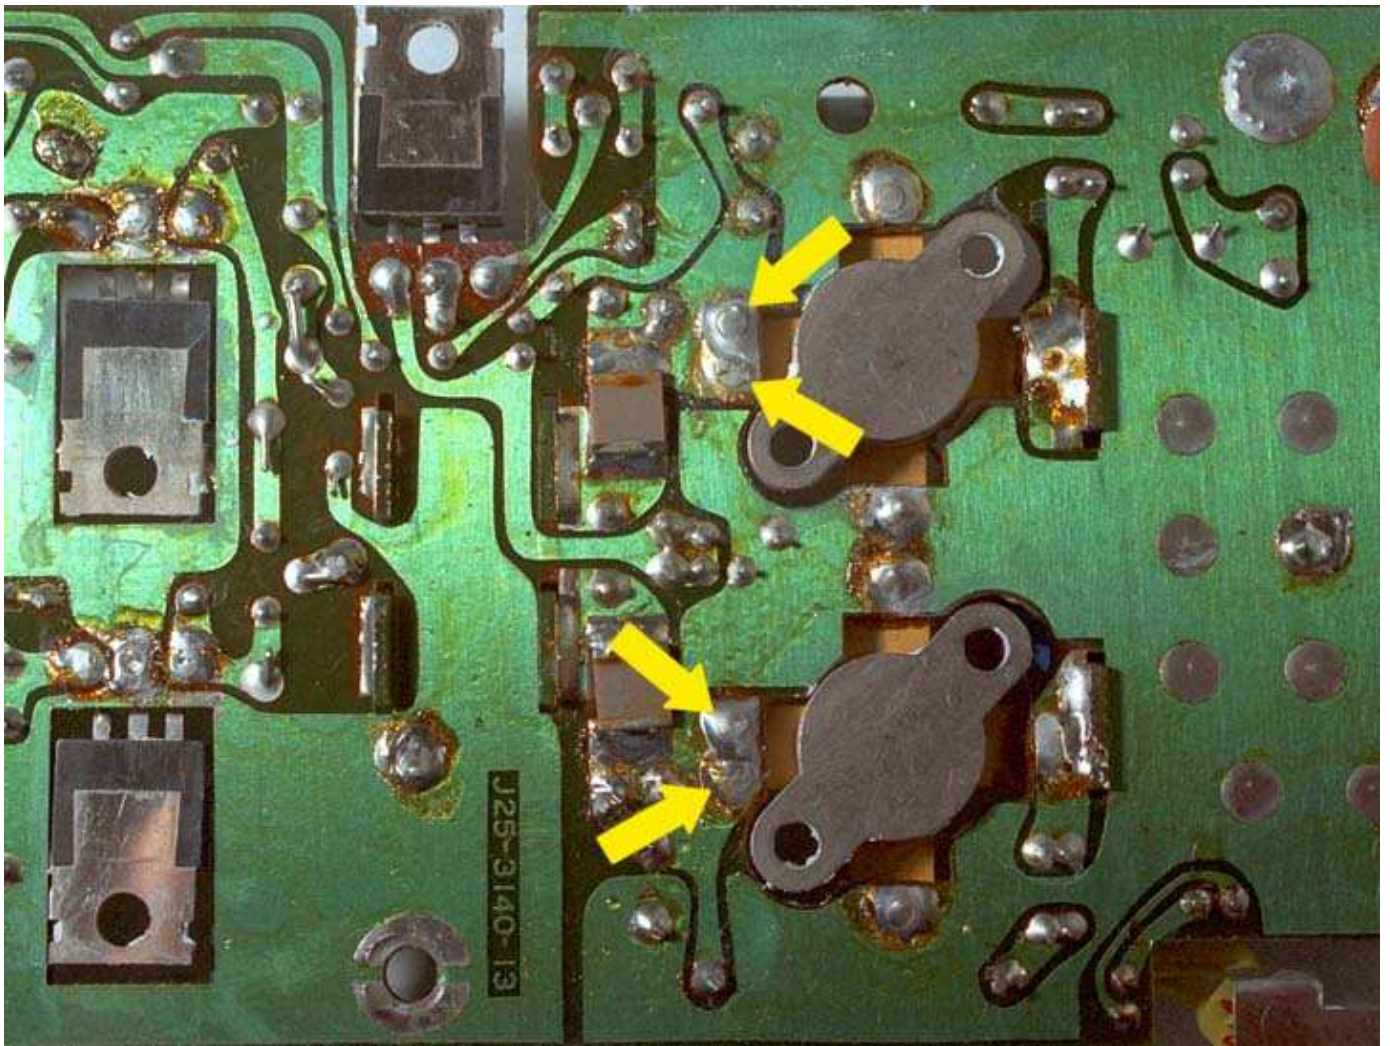
2) Remove the final amp PCB retaining screws, transistor retaining screws, and the thermistor retaining screw, and separate the board from the heat-sink. Note which transistors require mica washers, then clean off all of the old heat-sink compound with isopropanol and cotton buds. Inspect the PA transistor base via rivet heads (2 per transistor) on the underside of the PCB. A dark circle in the solder indicates that the connection has failed (even though it may exhibit a low DC resistance at the time of examination). The problem is clearly evident in the photograph below (yellow arrows), and the module shown was indeed producing distorted SSB. A cursory examination of the board also reveals failure of the emitter vias, but since the emitters are connected to the ground plane on both sides of the board, these additional failures do not prevent the unit from working.

Bridge the PA base vias with wire. This can be done without removing the transistors, by passing a wire through the gap to the side of the transistor tab. Also inspect all of the other vias on the board, particularly those at the driver transistors, and resolder as necessary.

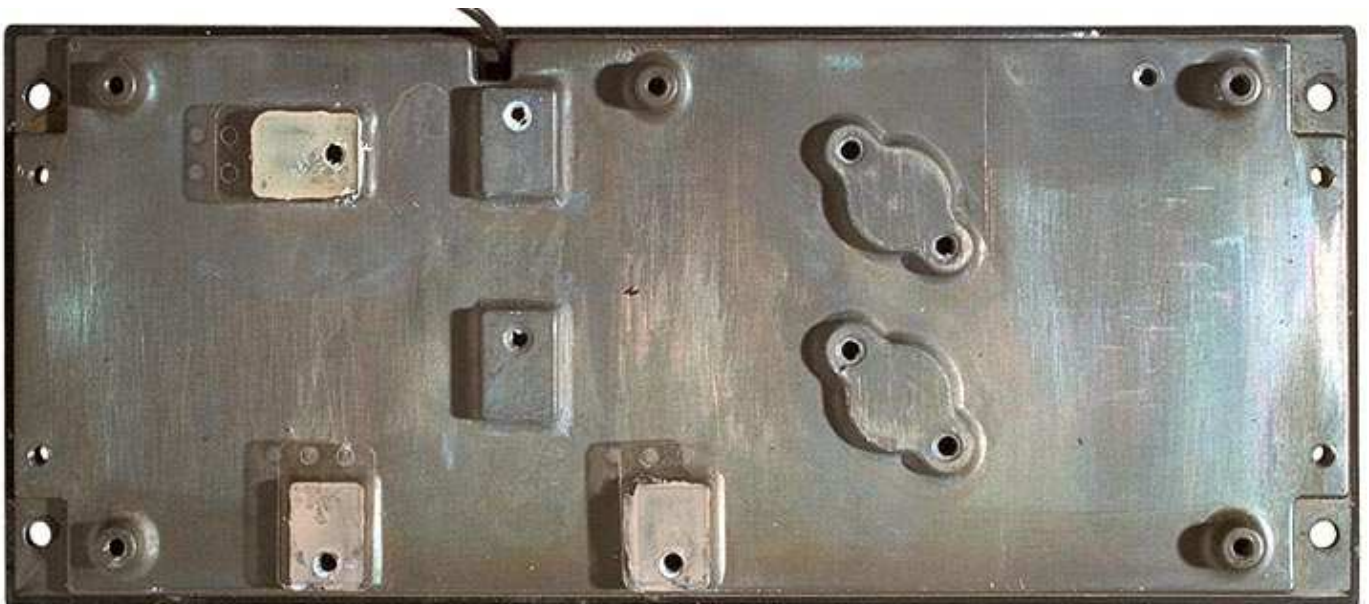
Heatsink in preparation for reassembly, showing which transistors require mica washers.

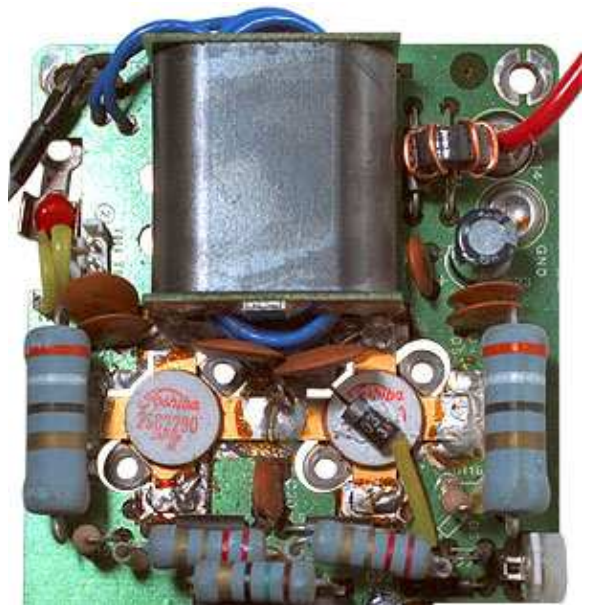
Output transformer and output transistors

- Avoid using excess heat-sink compound.
- Do not over-tighten transistor retaining screws. Leave time for the grease to extrude and then retighten.
- Re-solder SOE transistors after reassembly to relieve stresses.
- Remove old solder as far as possible and replace it, to reduce gold contamination.
- Check for shorts - bases measure  $7.5 \Omega$  to ground. Collectors o/c fwd, 0.53 V rev.
- Re-commission using a **current-limiting PSU**.
- Test initially at low power levels in case of loose or shorted output connectors. The operation of the SWR protection circuit depends on a proper connection between it and the amplifier.
- **Reset Bias** according to the procedure in the service manual.
- Check that the antenna connector is not loose. A faulty ground connection at this point can cause a bad SWR and activate the protection circuitry.

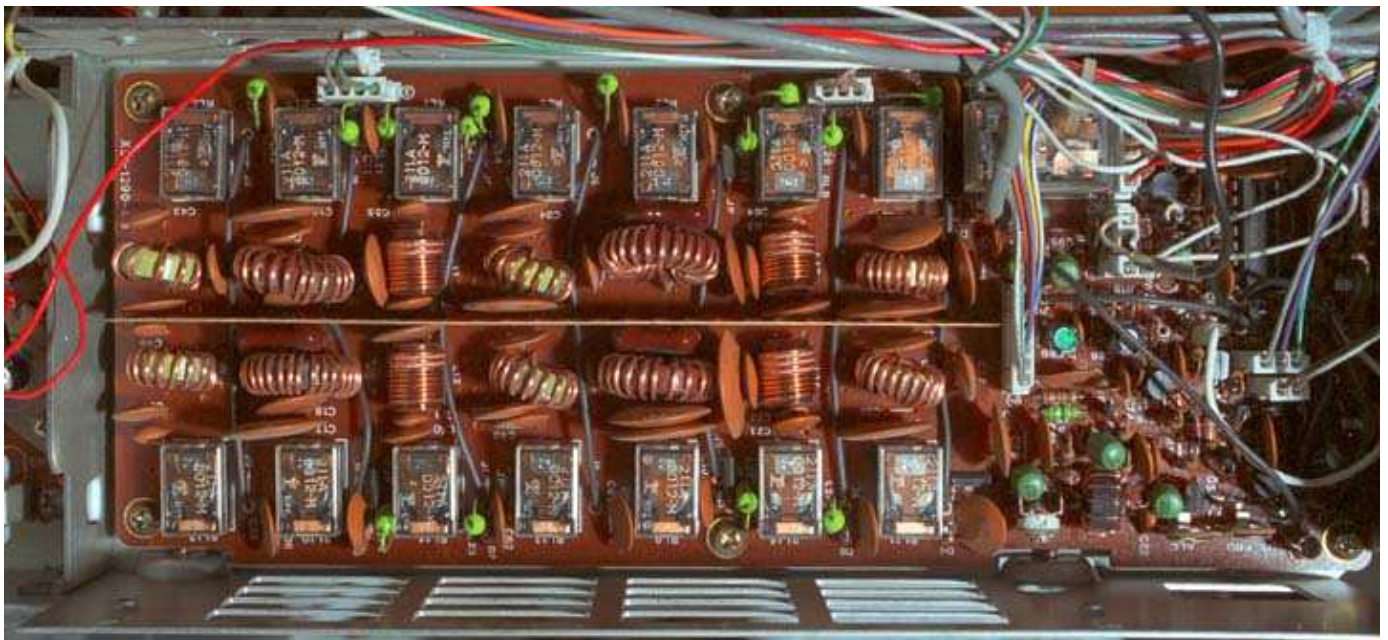
Relay-switched Low-pass filters used to remove harmonics from the transmitter output.
