# ATB-0028

### Title: TH-K2AT Reduced current drain when turned off

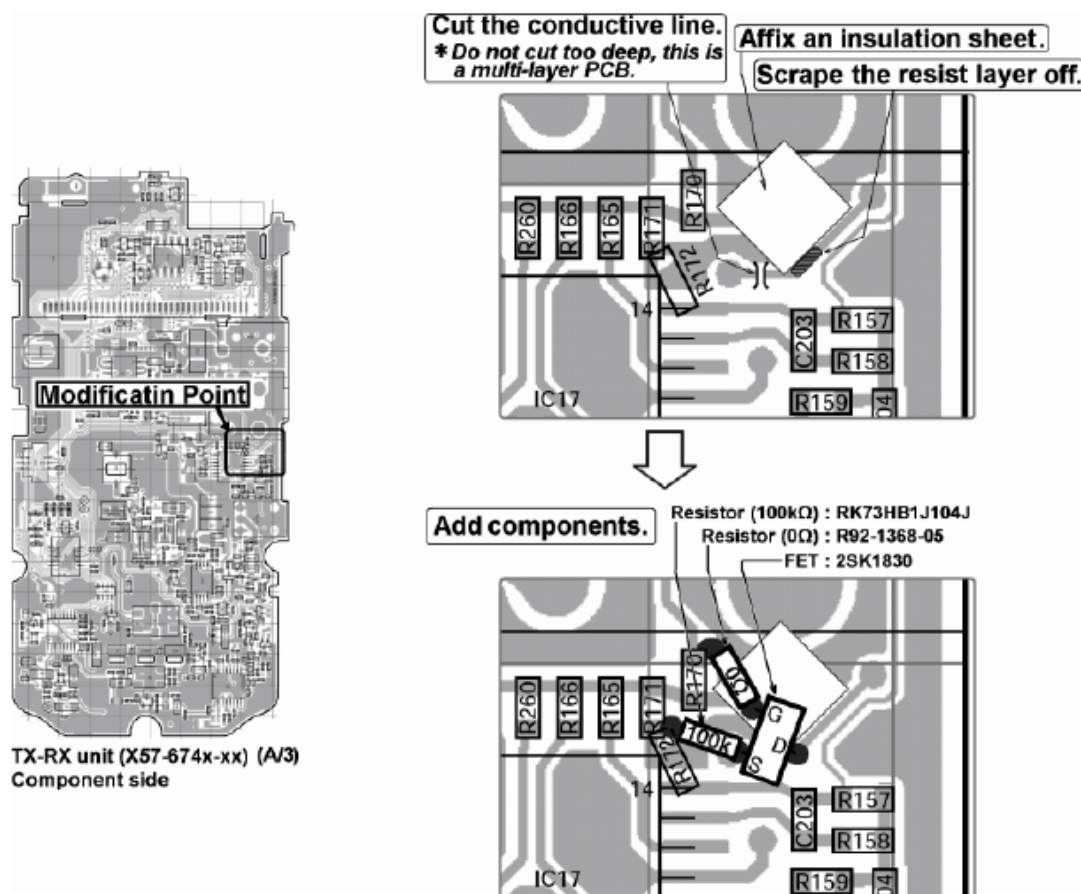
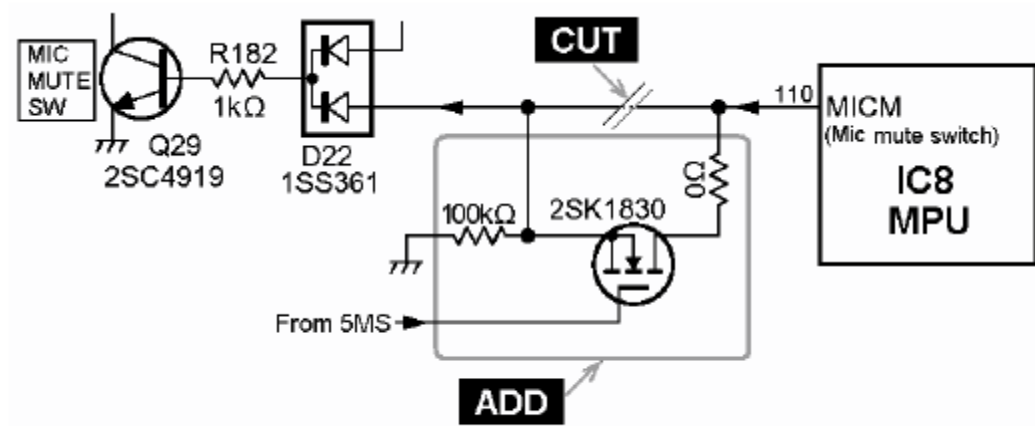
The microphone mute port of the MPU remains active when the transceiver is turned off, causing the battery pack to drain in a couple days. Production incorporated a new MPU at S/N 509xxxxx. Due to the difficulty in changing the MPU, the following hardware change was made available to correct the current drain condition.

Required Part #	Description
RK73HB1J104J	100K Resistor
R92-1368-05	0 Ohm Resistor
2SK1830	FET
